INSPECTION REPORT  
FOR  
PAXTON LANDFILLS I AND II  
Chicago, IL  
ILD069498186  
R05-8303-01F

June 23, 1986

DATE: June 23, 1986  
TO: File  
FROM: Cynthia Pugh CR  
SUBJECT: Illinois/R05-8303-01F/IL0030  
Chicago/Paxton I and Paxton II  
ILD069498186

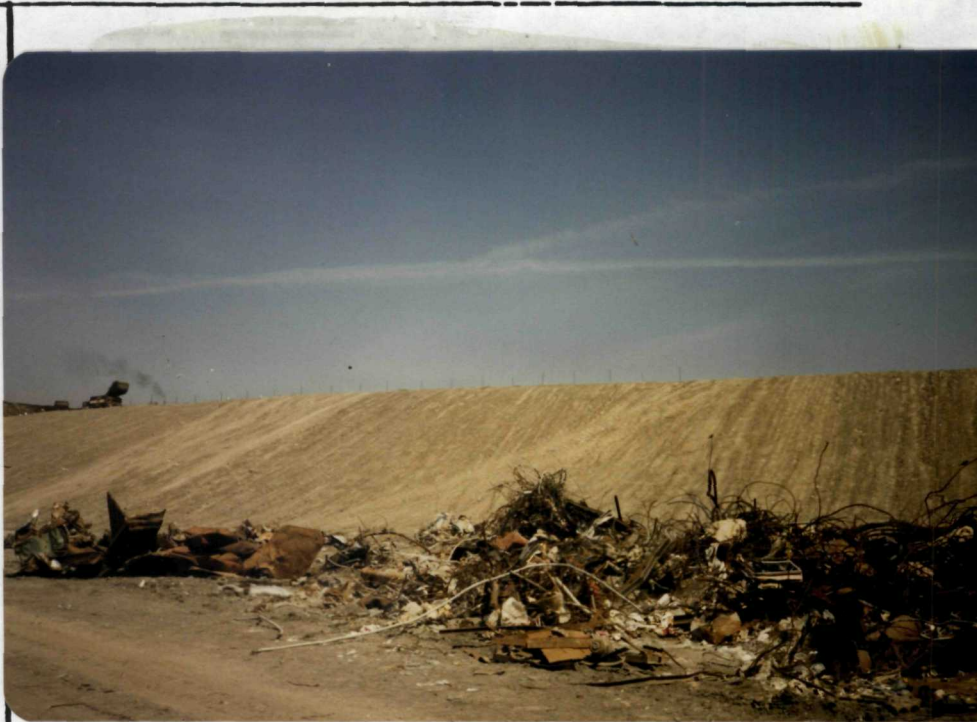
DATE 5-9-86TIME 10:50 (A.M.) P.M.DIRECTION: N NNE NE ENE  
E ESE SE SSE  
S SSW SW WSW  
W WNW (NW) NNWWEATHER 70°F, Clear  
and SunnySITE Paxton I and IITDD# R05PHOTOGRAPHED BY:  
Ruth Ann JacquetteSAMPLE ID# (if applicable)  
NADESCRIPTION: Parcel II of Paxton II Landfill.

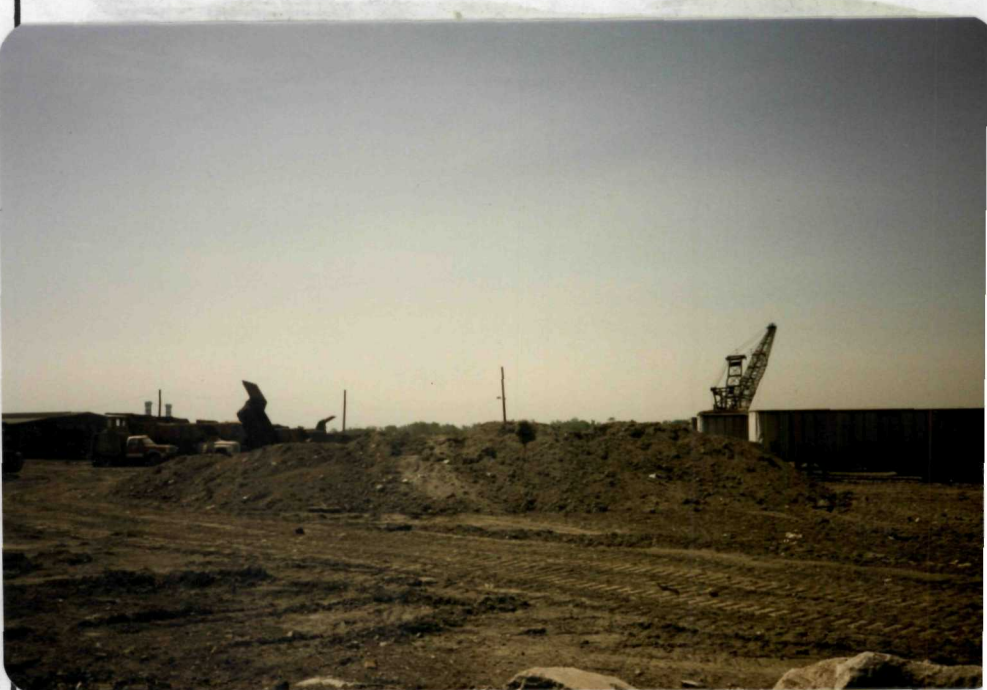
Page 2DATE 5-9-86TIME 10:55 (A.M.) P.M.DIRECTION: N NNE NE ENE  
E ESE SE SSE  
S SSW SW WSW  
W WNW NW NNWWEATHER 70°F, clear  
and sunnySITE Paxton I and IITDD# R05-8303-01FPHOTOGRAPHED BY:  
Ruth Ann JacquetteSAMPLE ID# (if applicable)  
NADESCRIPTION: Parcel I of Paxton II Landfill.

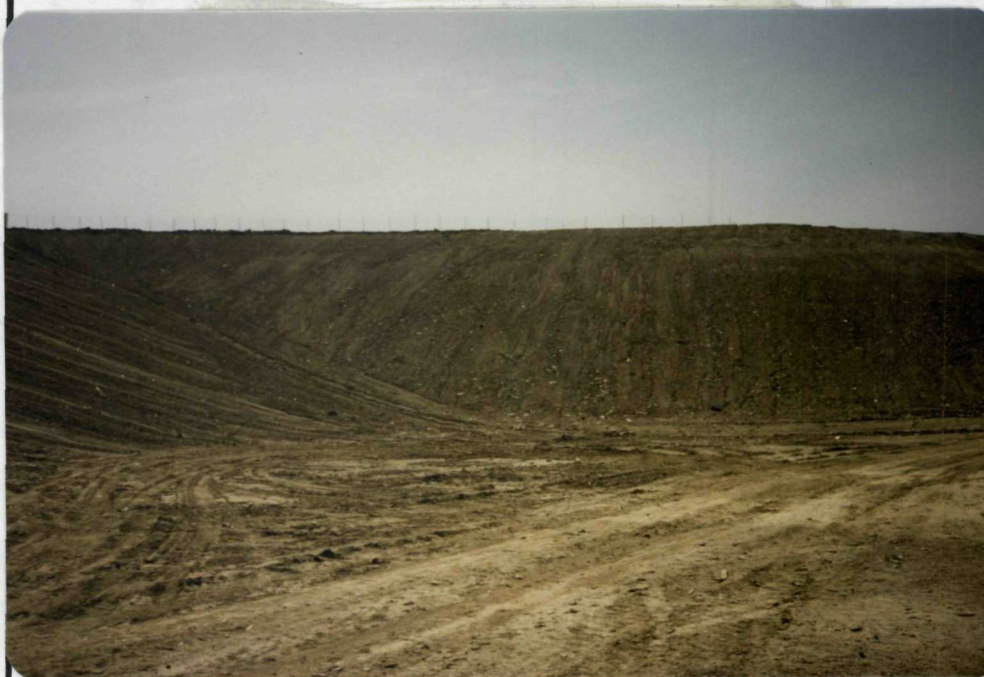
DATE 5-9-86TIME 10:55 A.M. P.M.DIRECTION: N NNE NE ENE  
E ESE SE SSE  
S SSW SW WSW  
W WNW NW NNWWEATHER 70°F, clear  
and sunnySITE Paxton I and IITDD# R05-8303-01FPHOTOGRAPHED BY:  
Ruth Ann JacquetteSAMPLE ID# (if applicable)  
NADESCRIPTION: Parcel I of Paxton II Landfill.

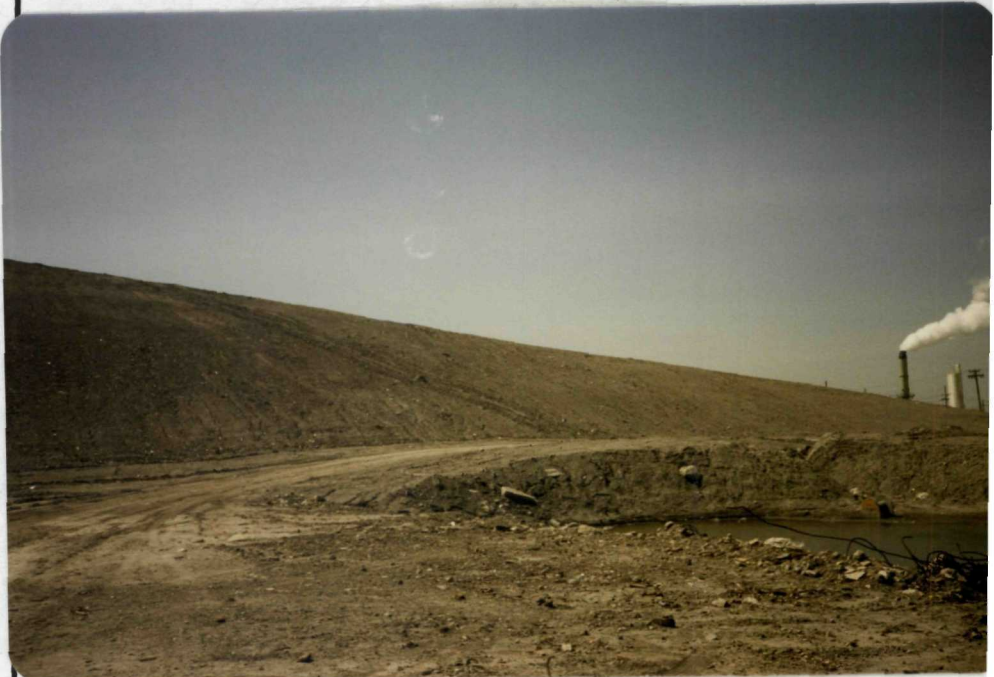
DATE 5-9-86TIME 10:55 (A.M.) P.M.DIRECTION: N NNE NE ENE  
E ESE SE SSE  
S SSW SW WSW  
W WNW NW NNWWEATHER 70° F. Clear,  
and Sunny.SITE Paxton I and IITDD# R05-8303-0FPHOTOGRAPHED BY:  
Ruth Ann JacquetteSAMPLE ID# (if applicable)  
NADESCRIPTION: Parcel I of Paxton II Landfill.

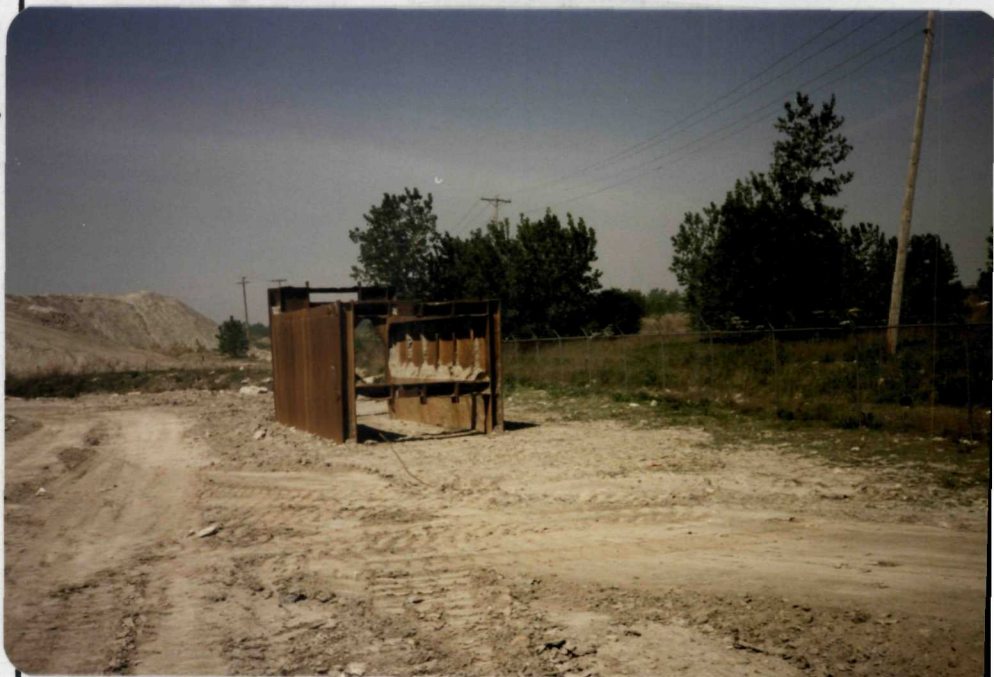
DATE 5-9-86TIME 11:00 (A.M.) P.M.DIRECTION: (N) NNE NE ENE  
E ESE SE SSE  
S SSW SW WSW  
W WNW NW NNWWEATHER 70° F, Clear  
SunnySITE Paxton I and IITDD# R05-8303-01FPHOTOGRAPHED BY:  
Both Ann JacquetteSAMPLE ID# (if applicable)  
NADESCRIPTION: Off-site property

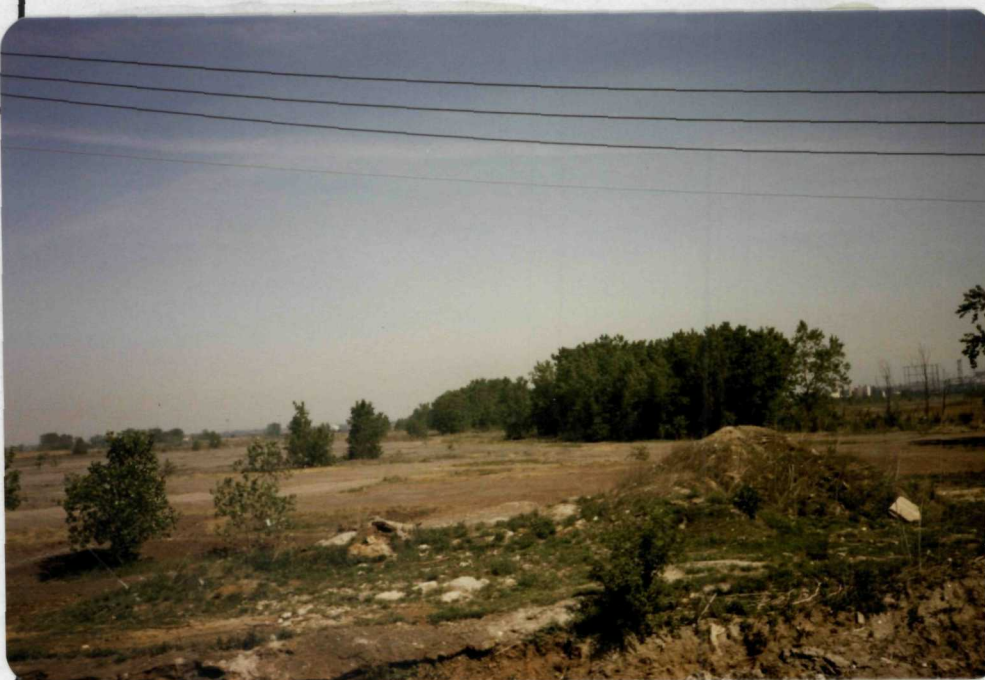
DATE 5-9-86TIME 11:00 (A.M.) P.M.DIRECTION: N NNE NE ENE  
E ESE (S) SSE  
S SSW SW WSW  
W WNW NW NNWWEATHER 70° F, Clear, and  
SunnySITE Paxton I and IITDD# R05-8303-01FPHOTOGRAPHED BY:  
Both Ann JacquetteSAMPLE ID# (if applicable)  
NADESCRIPTION: Paxton I Landfill.

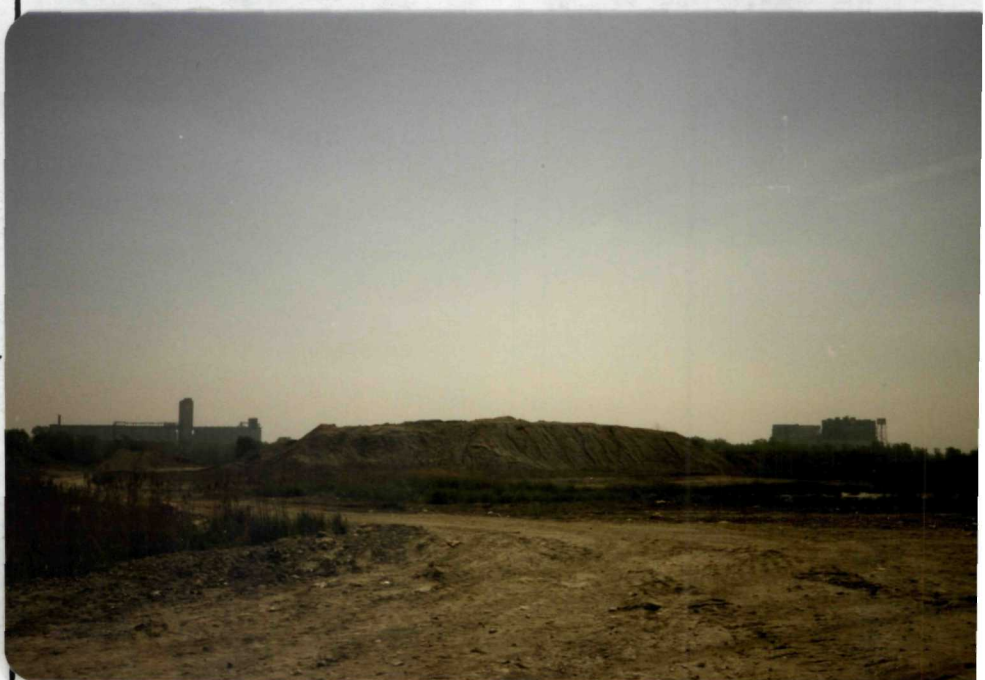
DATE 5-9-86TIME 11:00 (A.M.) P.M.DIRECTION: N NNE NE ENE  
E ESE SE SSE  
S SSW SW WSW  
W WNW NW NNWWEATHER 70°F, clear  
and sunnySITE Paxton I and IITDD# R05-8303-0FPHOTOGRAPHED BY:  
Ruth Ann JacquetteSAMPLE ID# (if applicable)  
NADESCRIPTION: Parcel III of Paxton II Landfill.
